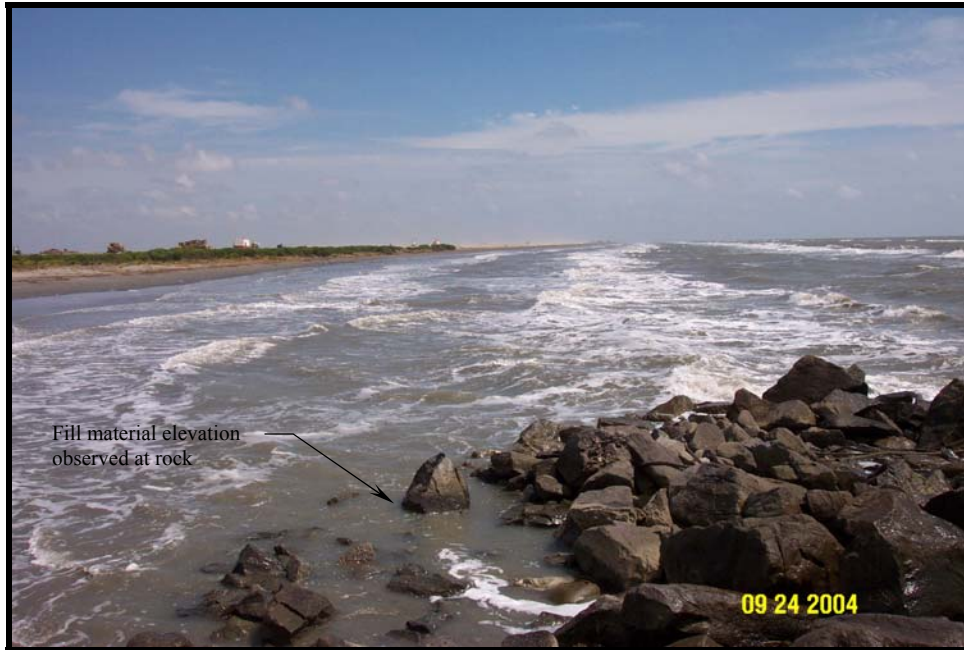
Photo 1. Post-Tropical Storm Ivan: View of beach fill, standing on top of existing rock shoreline protection at appx. Sta. 100+00 looking east (tide: appx. 1.7' NAVD)

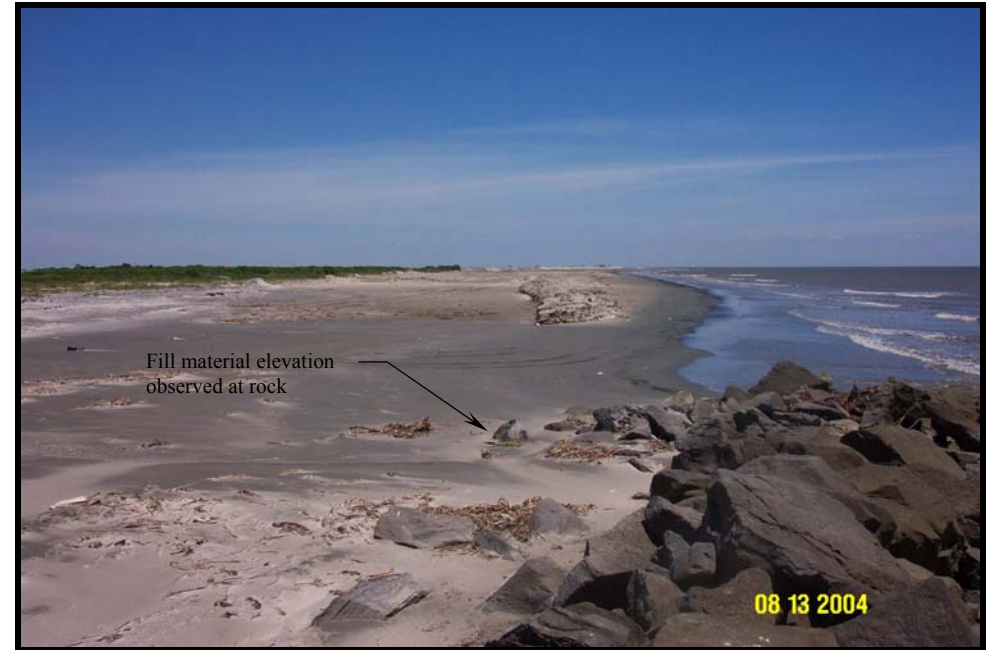
Photo 3. Pre-Hurricane Ivan: View of beach fill, standing on top of existing rock shoreline protection at appx. Sta. 100+00 looking east (tide: appx. 1.5' NAVD)

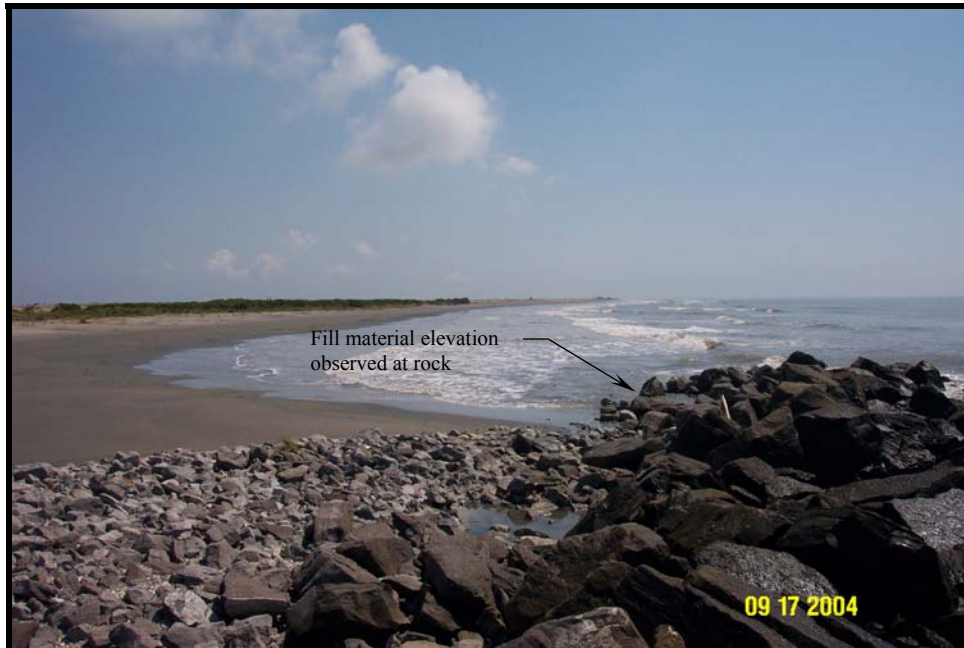
Photo 2. Post-Hurricane Ivan: View of beach fill, standing on top of existing rock shoreline protection at appx. Sta. 100+00 looking east (tide: appx. 1.3' NAVD)

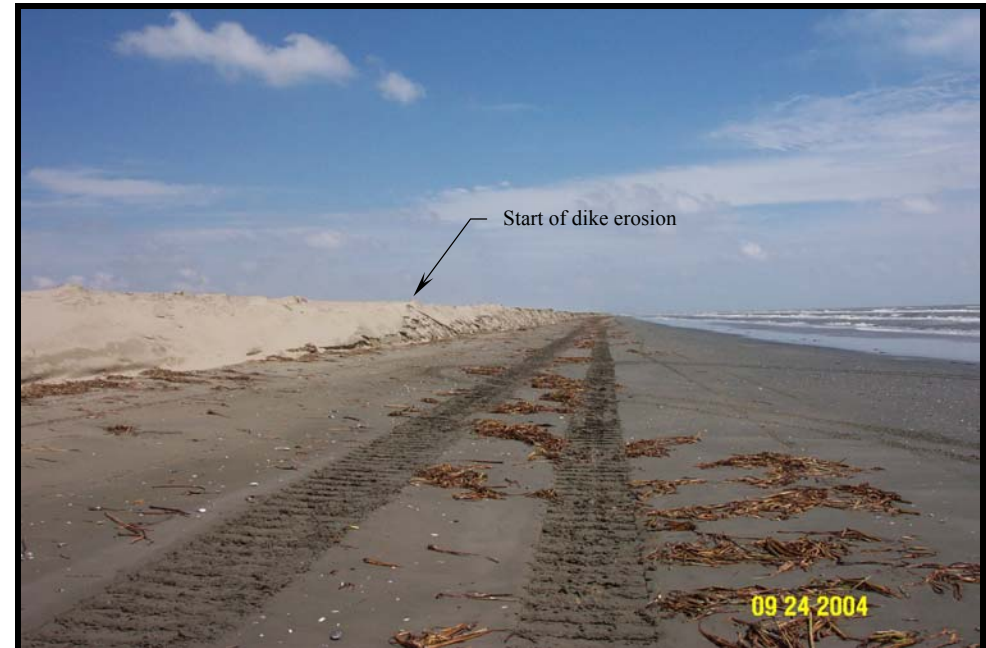
Photo 4. Beginning of front dike erosion at appx Sta. 135+00 looking east

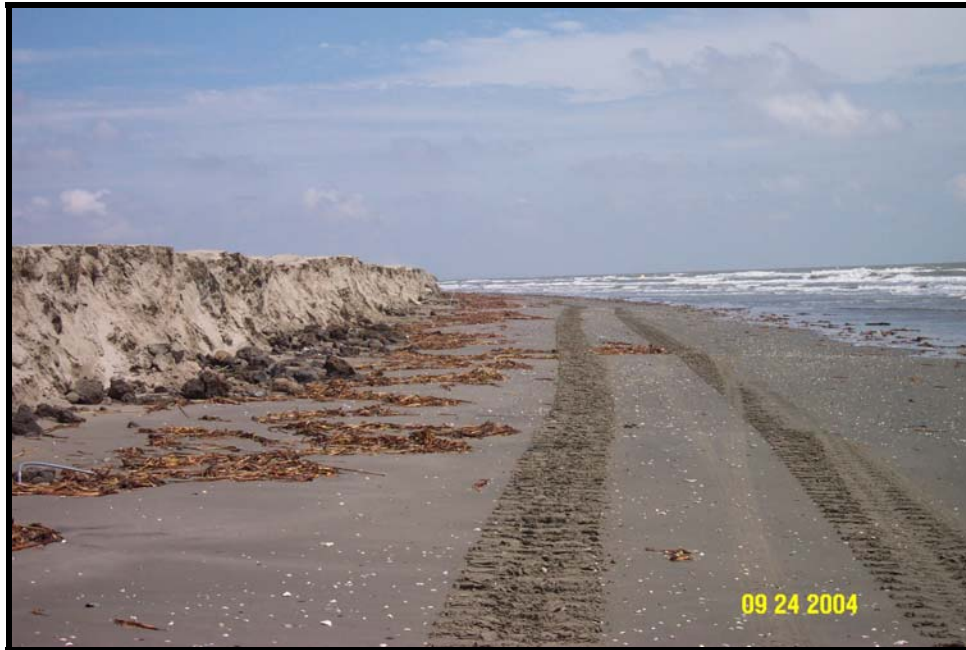
Photo 5. *Dune erosion at Sta. 195+00, looking east*

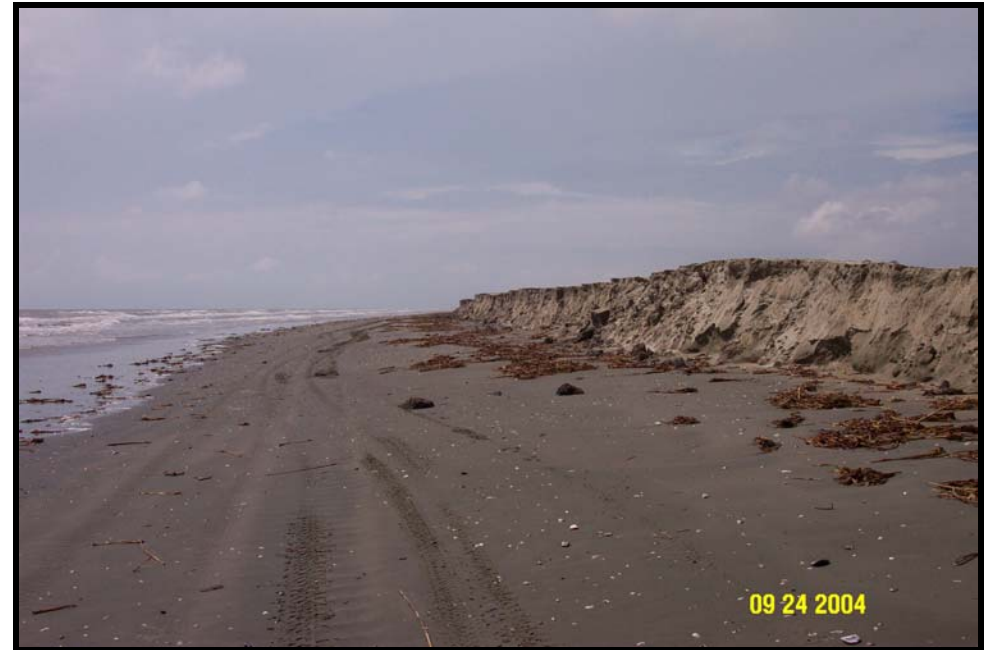
Photo 7. *Dune erosion at Sta. 199+00, looking west*

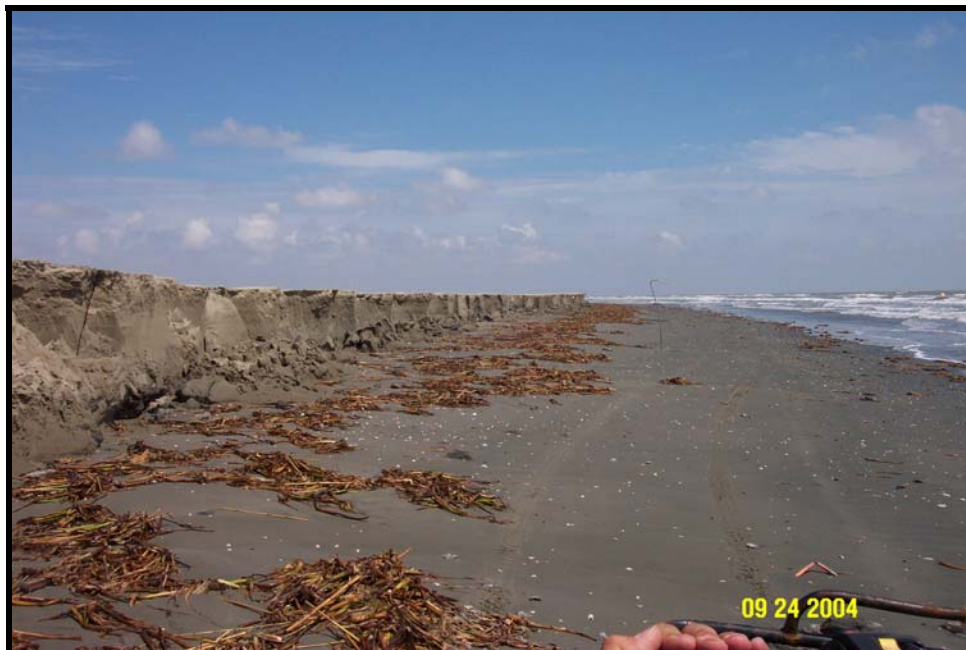
Photo 6. *Dune erosion at Sta. 199+00, looking east*

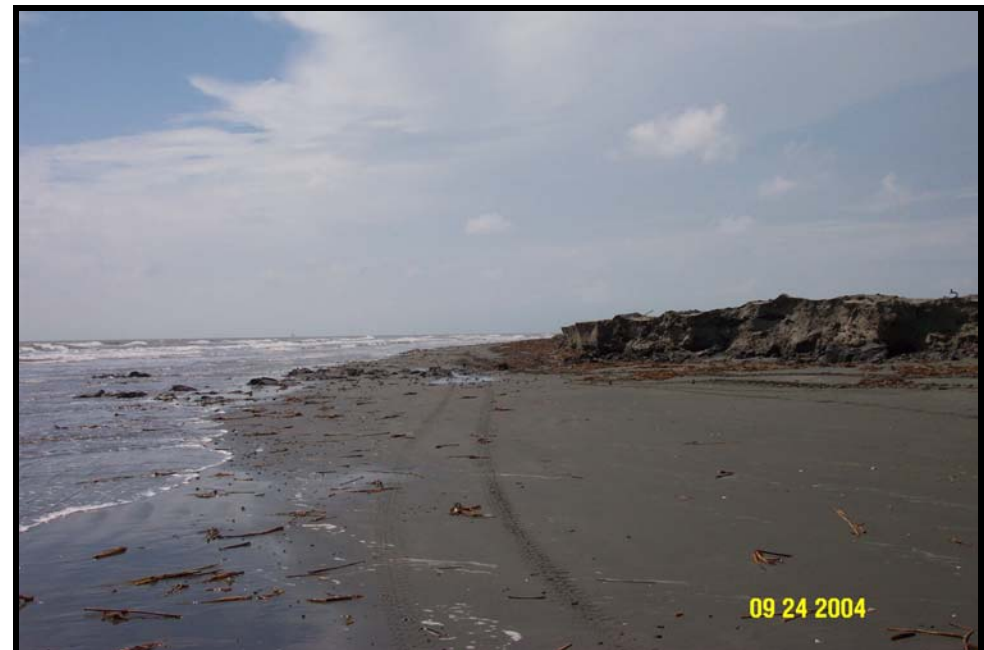
Photo 8. *Dune erosion at Sta. 206+00 (east end of project), looking west*

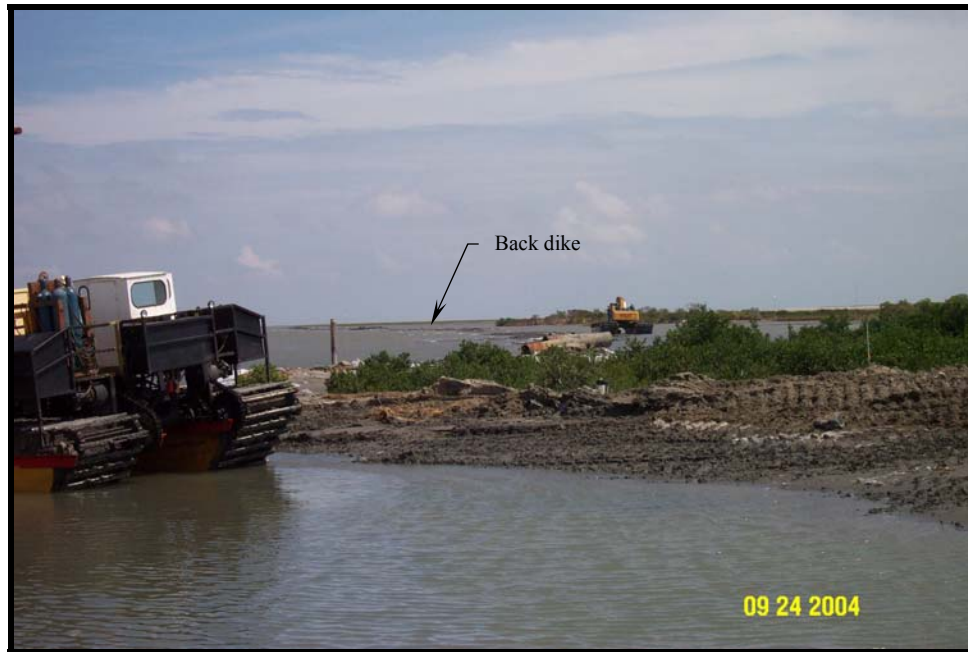
Photo 9. *View of back dike, standing at dock (Sta. 170+00) looking east (tide: appx. 1.5' NAVD)*
